Manhole Inspection Summary

Manhole # S13KK1026MH

Insp Date: **12/14/06 10:47 AM**

Location Address: **4601 PALL MALL RD**

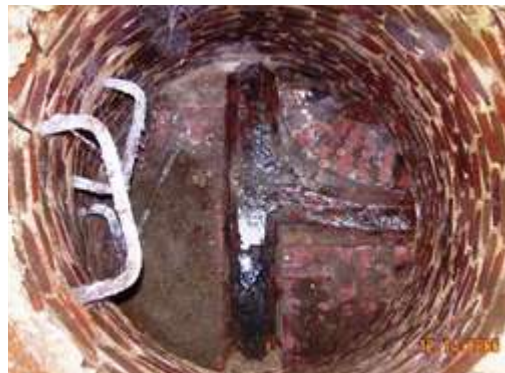
Top View

Frame leaks. Adjustment deterioration and infiltration. Corbel infiltration. Bench and Channel debris. Corroded steps.

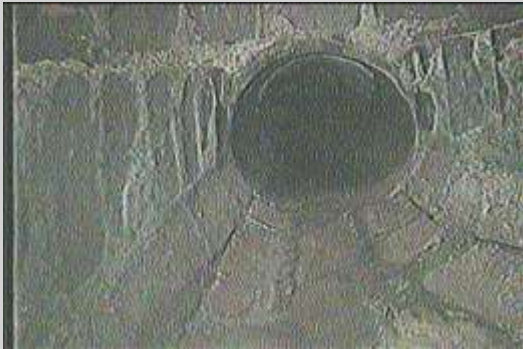
8 in. Circular Gravity Sewer Pipe Out @ 12 O'Clock

Deposits: ☐ None ☐ Mud ☐ Sludge ☐ Debris ☒ Grease

Silt Depth: **0** (in.) Deposits Extent: **Light**

Infiltration: **Evidence** Pipe Seal Cond: **Unknown**

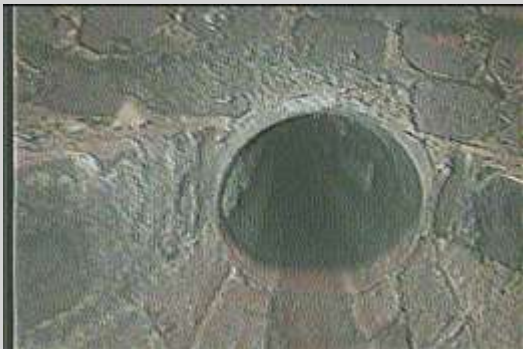
8 in. Circular Gravity Sewer Pipe In @ 3 O'Clock

Deposits: ☐ None ☐ Mud ☐ Sludge ☐ Debris ☒ Grease

Silt Depth: **0** (in.) Deposits Extent: **Light**

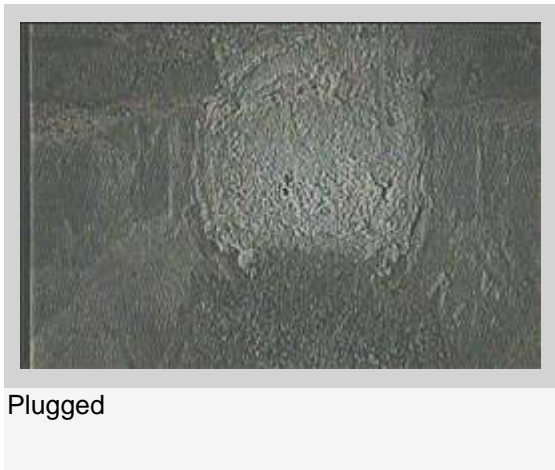
Pipe In @ 6 O'Clock

Connects To: **Stub connection / abandoned**
☐ Possible Illicit Connection
